Down-hole Camera of EPA Pavillion
Monitoring Well MW-02
Conducted on May 2, 2012
Prior to Redevelopment by the USGS

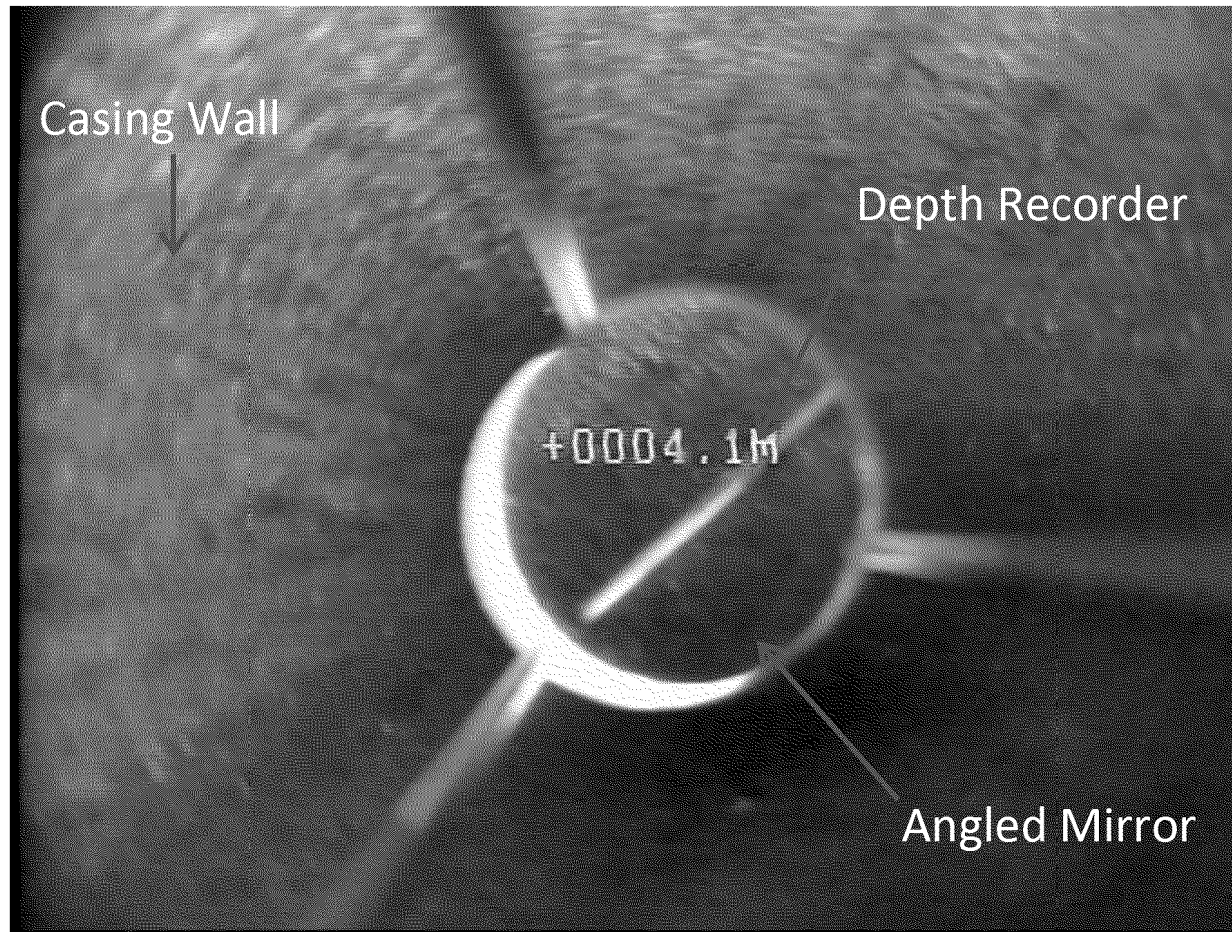
VT5_02_1.VOB at 0:0016

Blank casing in upper section of well.

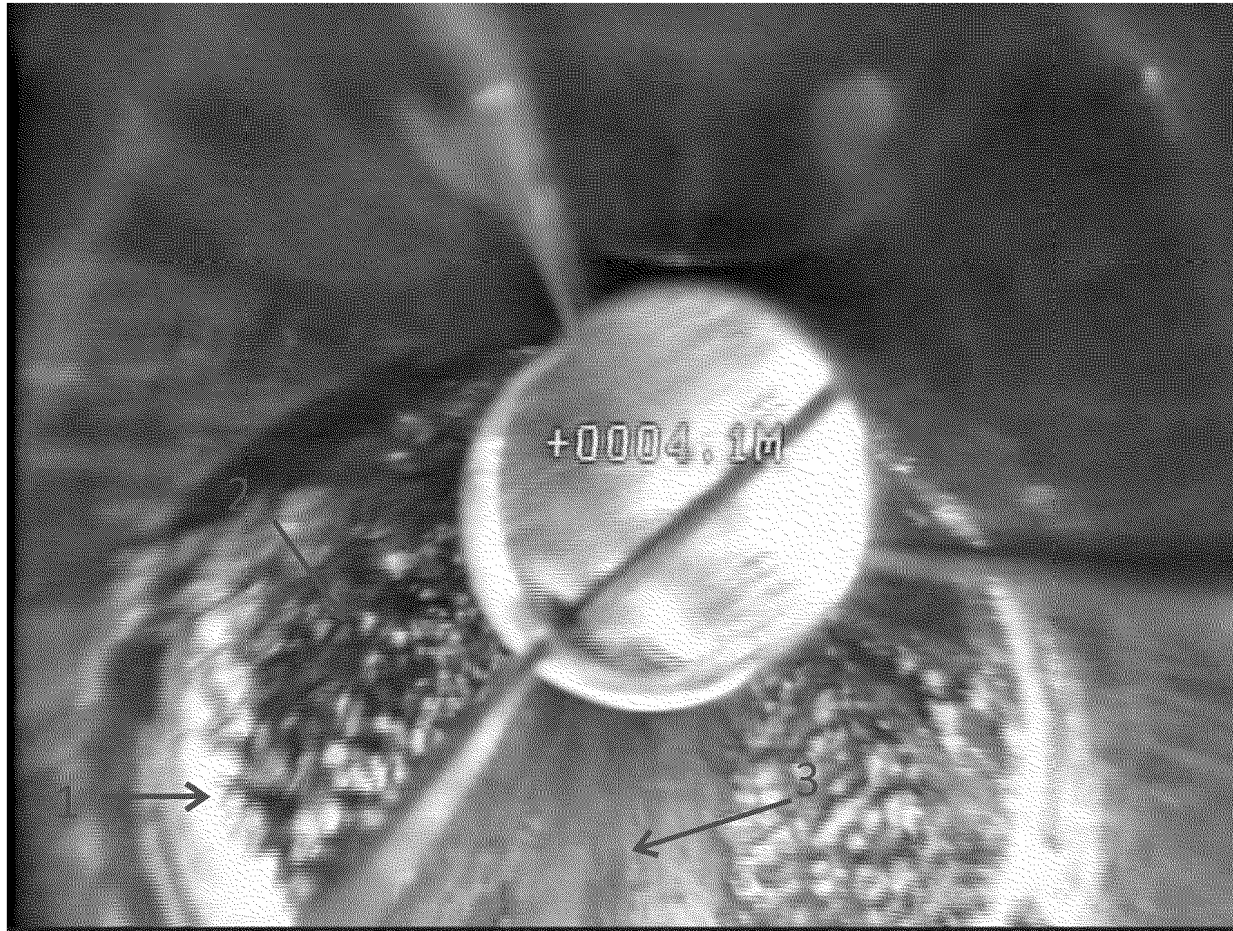
VTs_02_1.VOB at 0:07:49

Casing coupler threads exposed between pipe ends (1) and corrosion of casing below joint (2). 'Scuffed' sidewall of casing pipe (3).

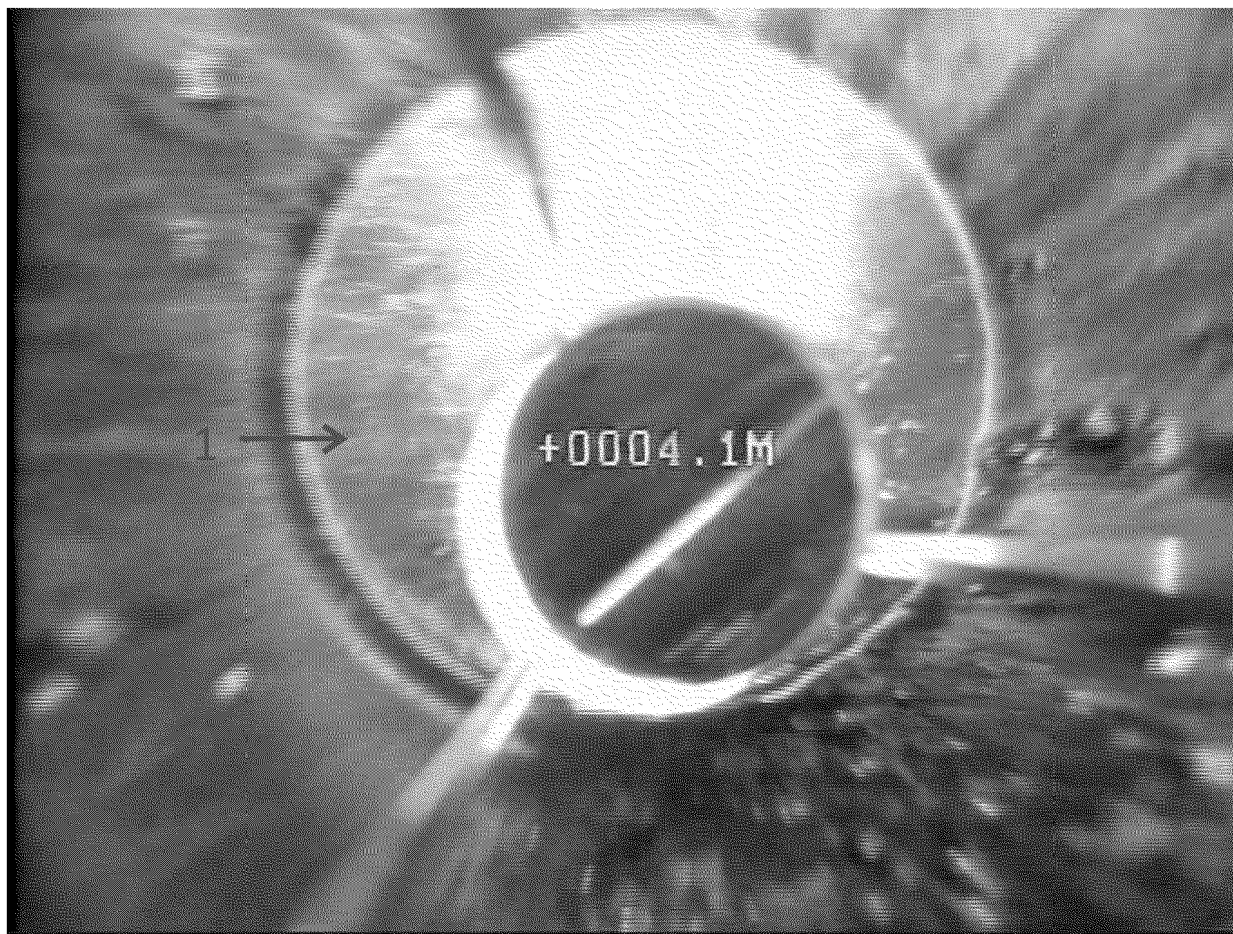
VTs_02.1.VOB at 0:07:54

Water surface (1) encountered at approximately 173-ft below top of casing (btoc).

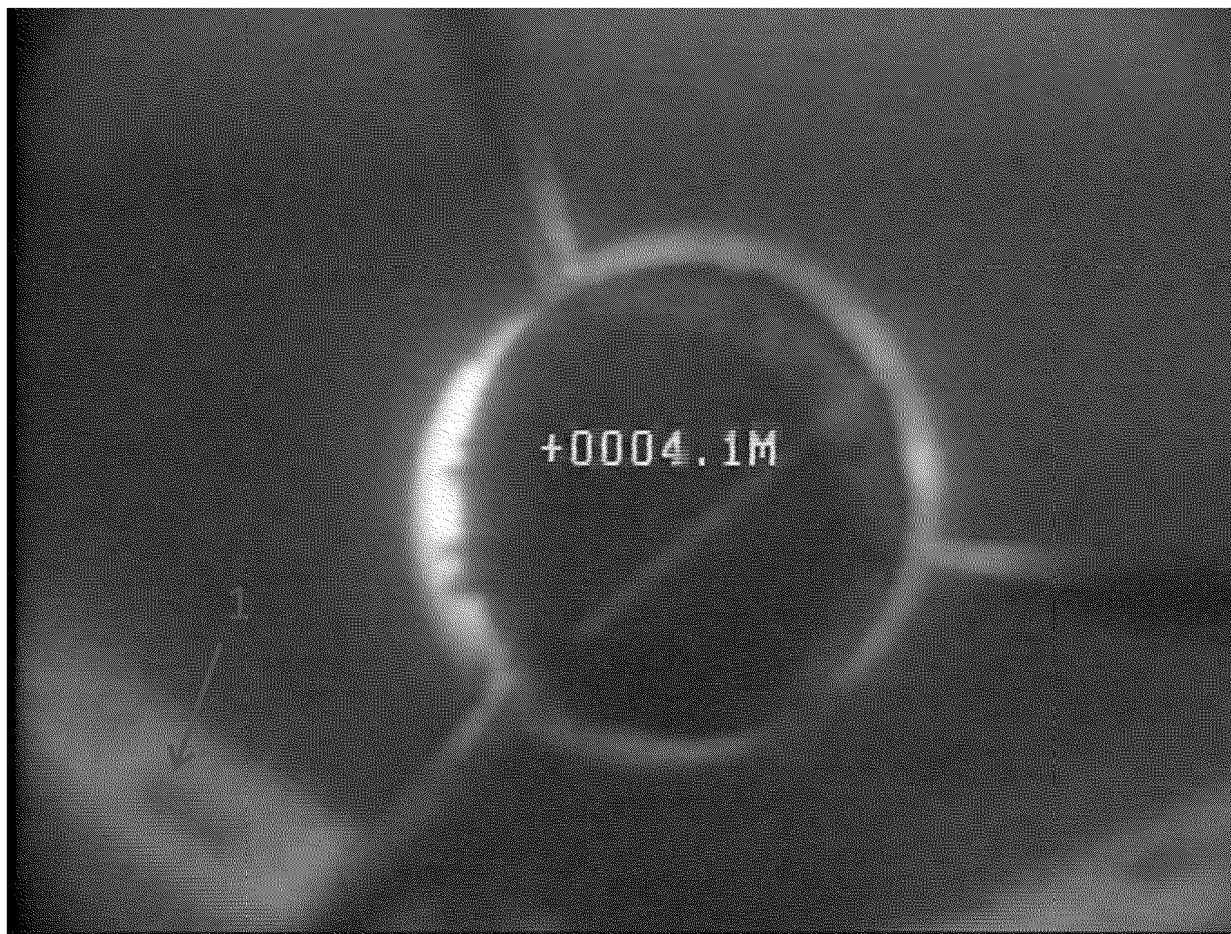
VTs_02_1.VOB at 0:11:37

Visible threaded casing joint below water surface (1), and example of water clarity.

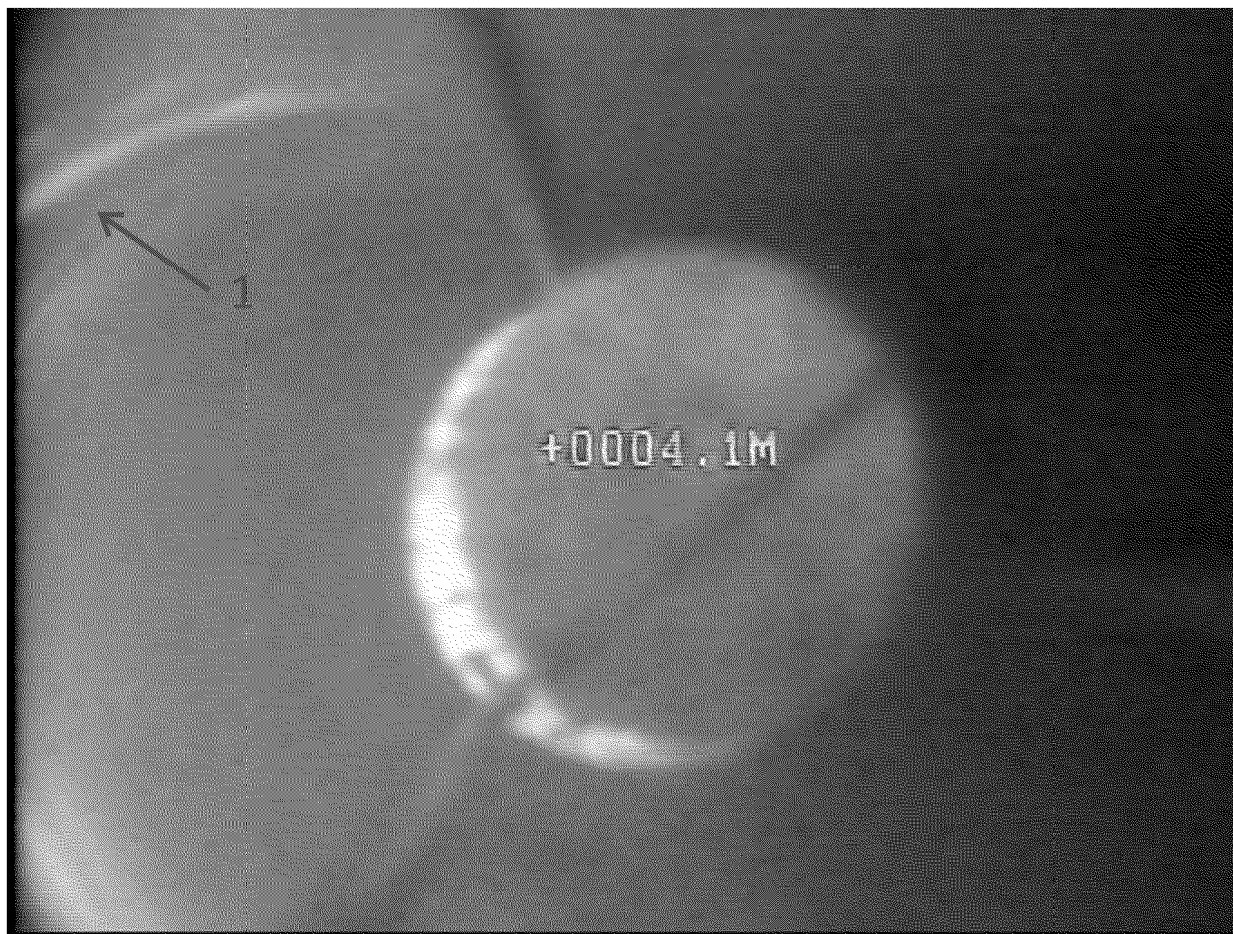
VTs_02_3.VOB at 0:10:29

Water clarity is sufficient again to see threaded casing joints (1).

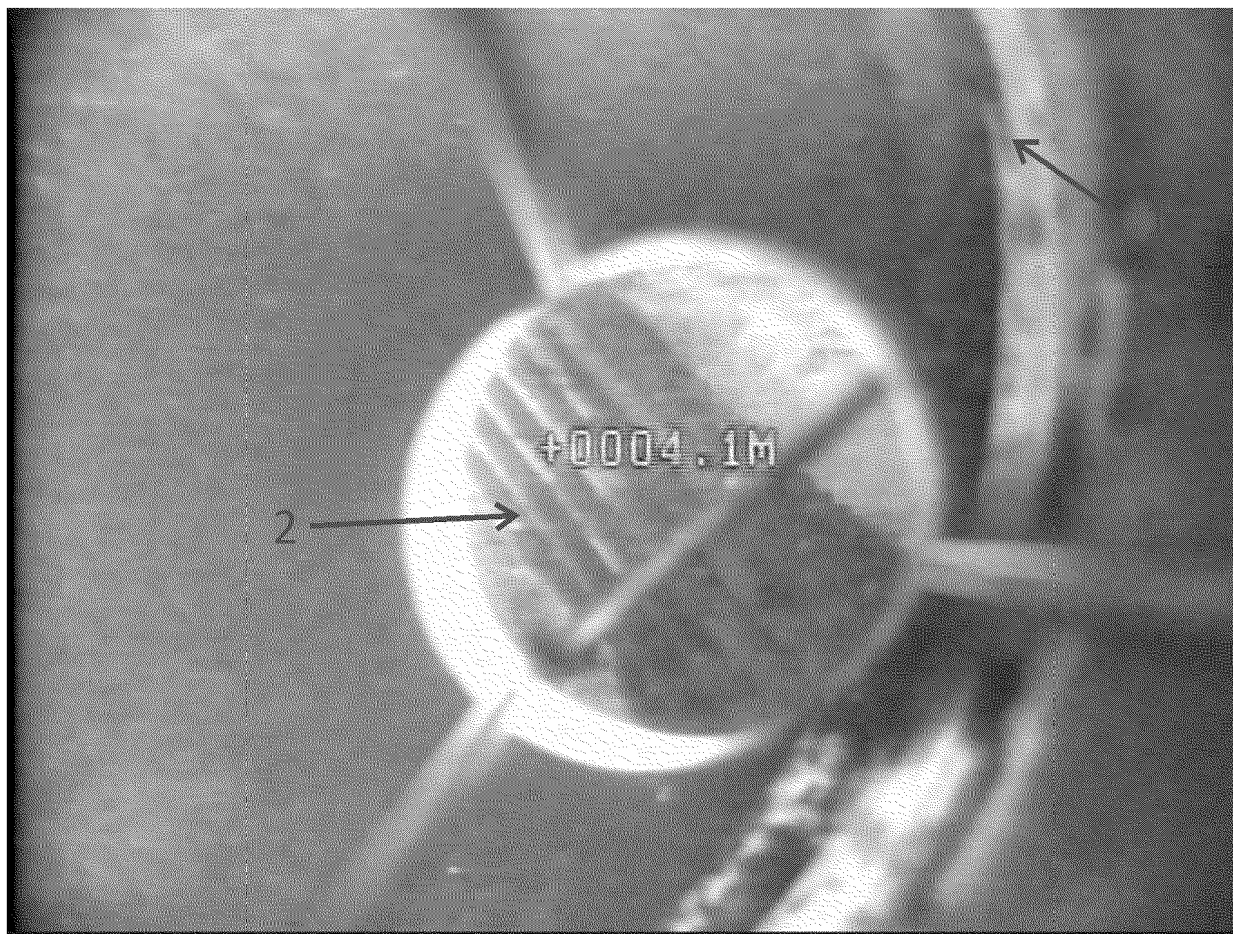
VTs_02_3.VOB at 0:12:07

Threaded casing joint (1) and still image of exposed threads in mirror (2).

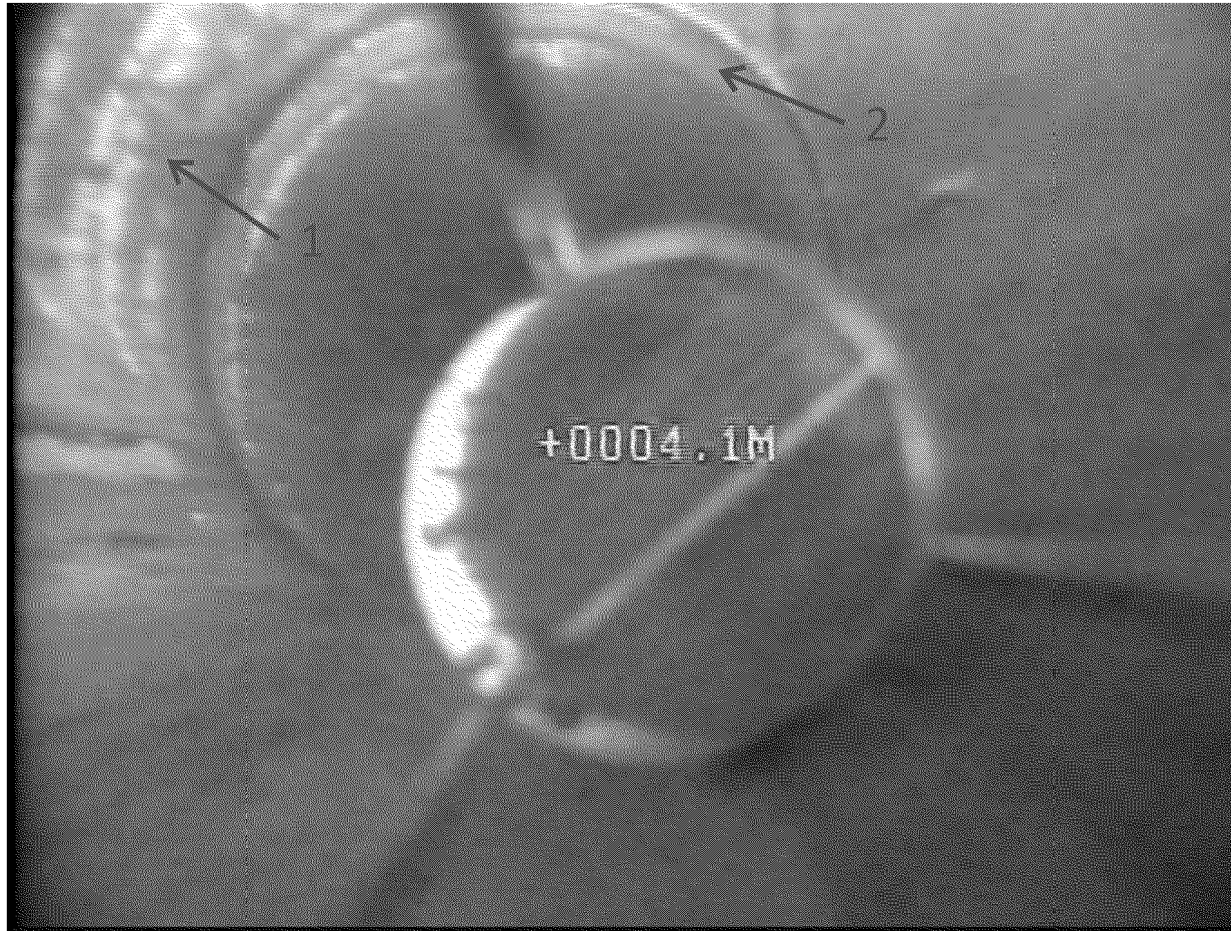
VTs_02_1.VOB at 0:01:18

'Scuffed' area (1) on casing sidewall just prior to threaded joint (2). This 'scuffing' appears prior to other threaded joint locations.

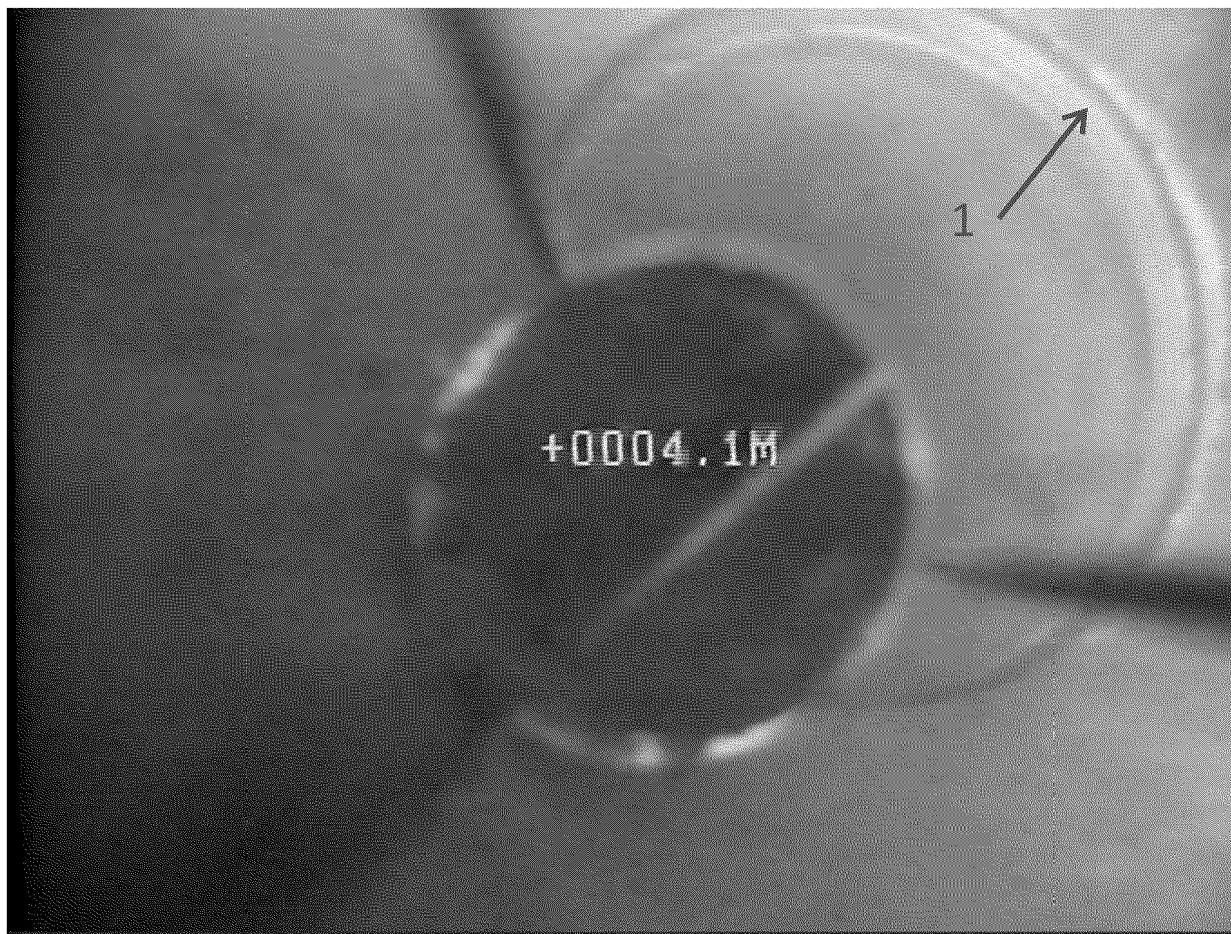
VST_02_4.VOB at 0:06:43

Threaded joint (1) prior to screened interval.

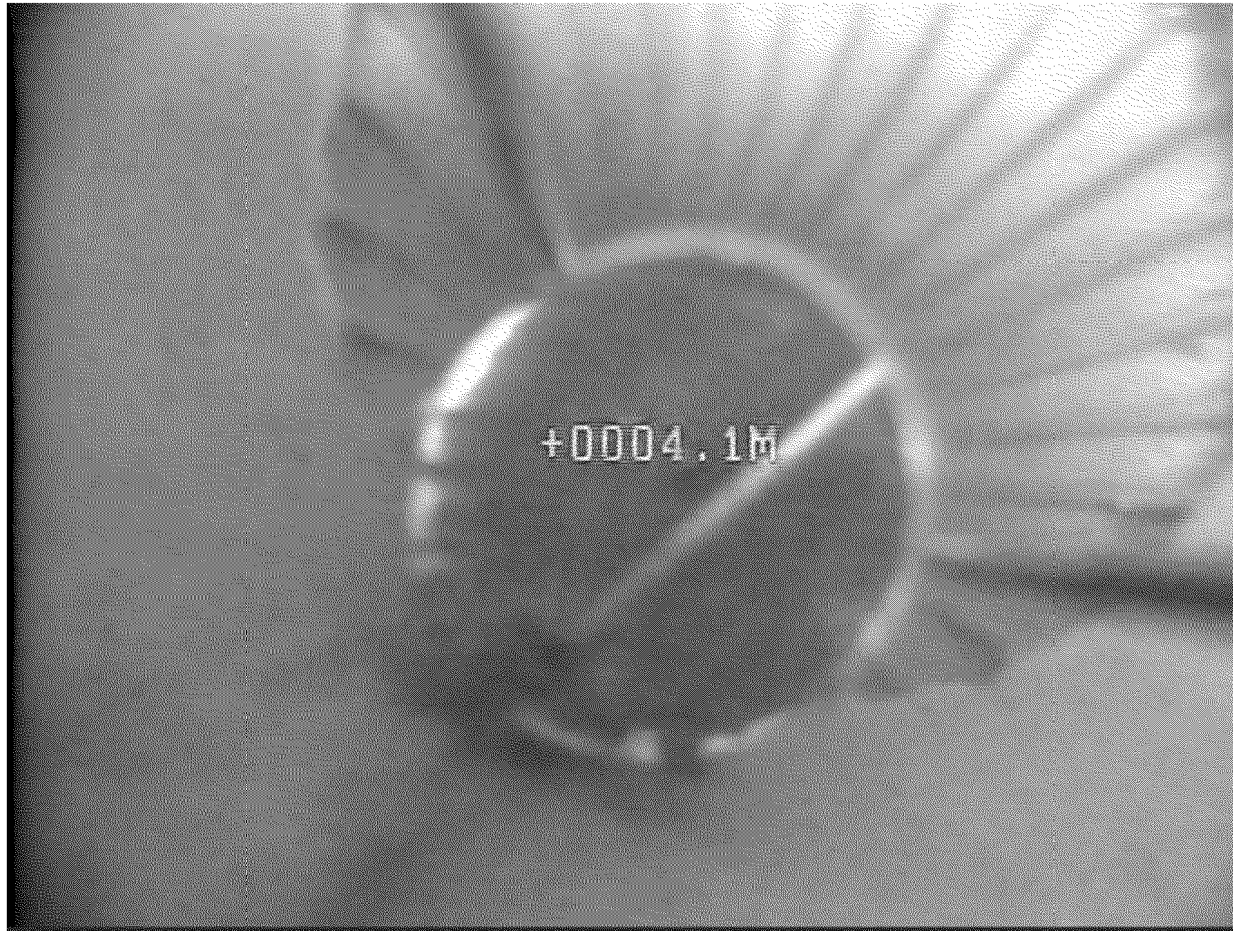
VST_02_4.VOB at 0:06:46

Top of screened interval, encountered at approximately 973-ft btoc.

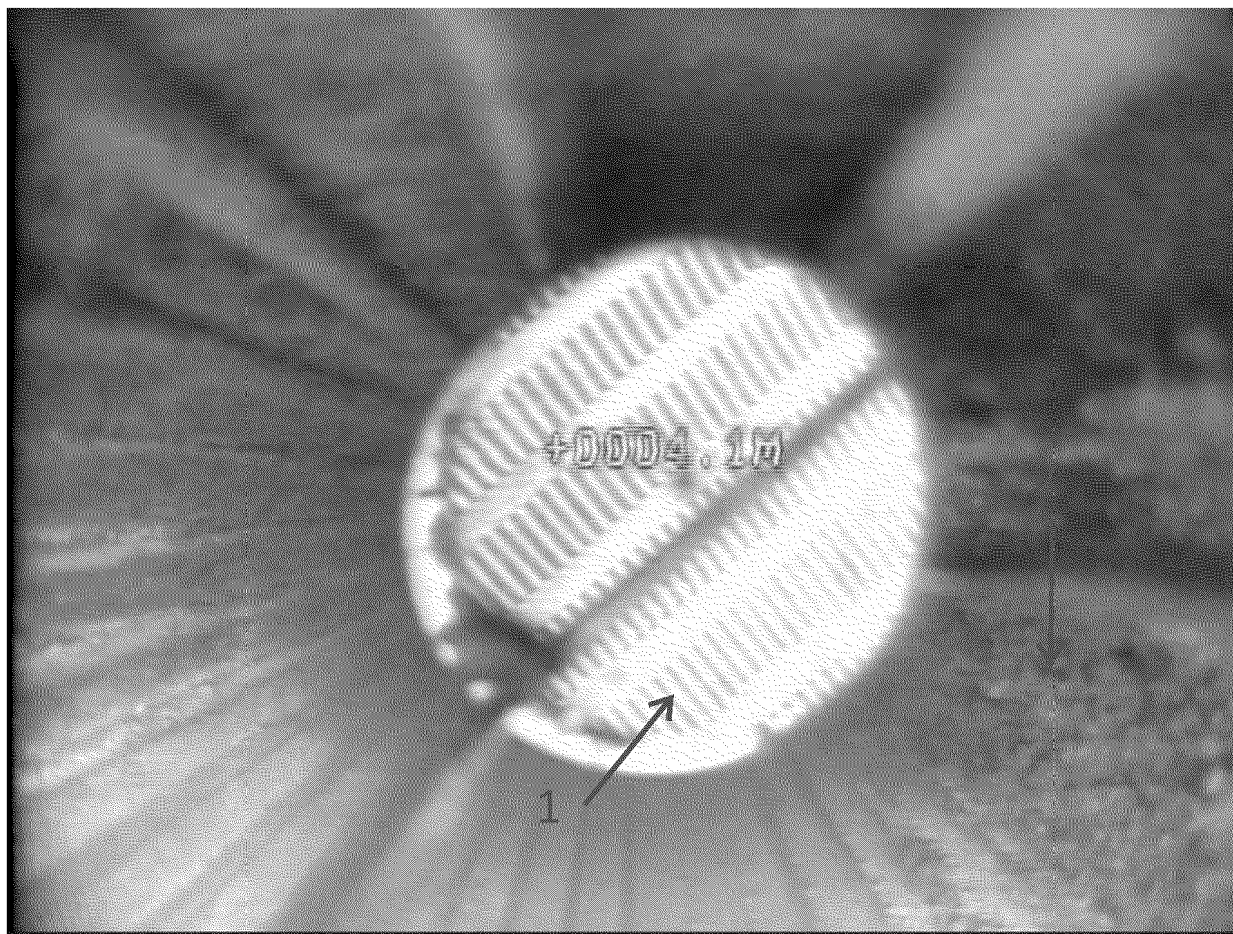
VST_02_4.VOB at 0:10:03

Image of screened interval (1) and material on screen (2).

- Video suggests that flow into the well is restricted based on accumulation of material on well screen.
- Due to depth discrepancy of completed well, it appears the screened interval of the monitoring well was completed within the drill cuttings and drill mud used to fill the open hole.
- Mineral accumulation within the well indicates the well casing was not constructed of stainless steel as originally reported by EPA. This has been confirmed by EPA.
- Blank well casing was coated on exterior of pipe with unknown black material, probably a corrosion inhibitor. See Figure C21 or Figure C22 in EPA Draft report.

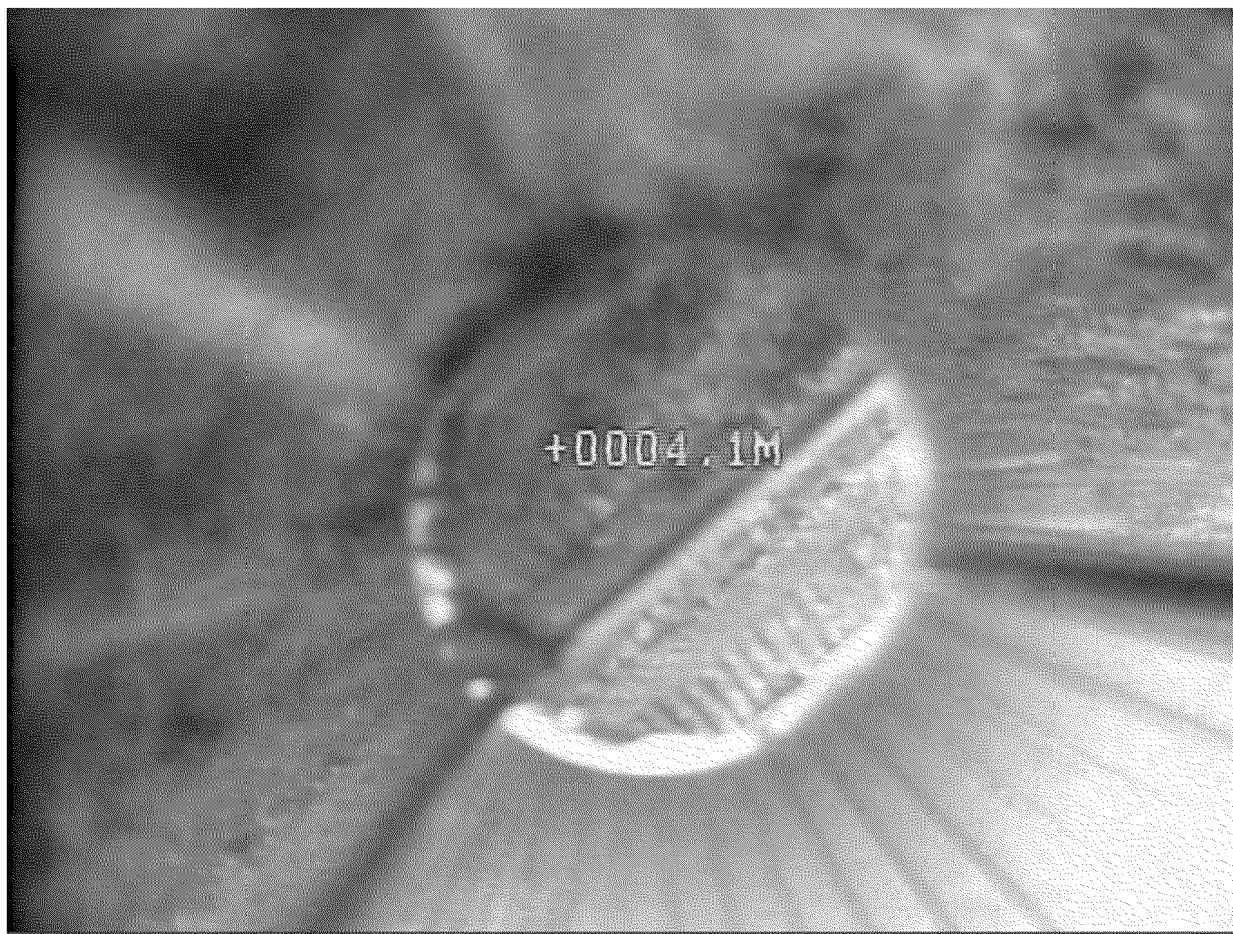
VST_02_4.VOB at 0:10:24

Material on well screen.

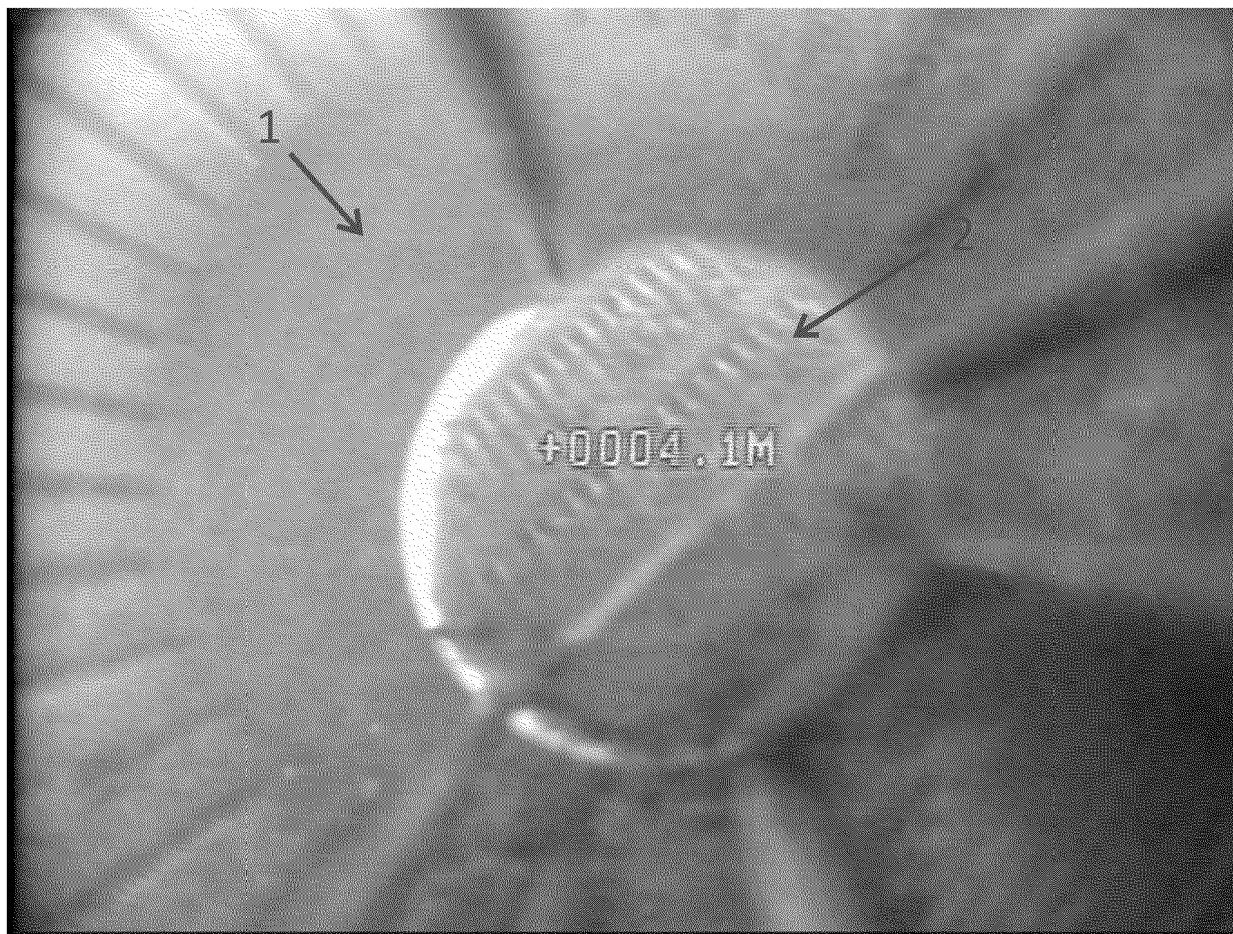
VST_02_4.VOB at 0:14:04

Bottom of well tagged at approximately 989-ft btoc with material visible at bottom of hole (1), and material on well screen (2).

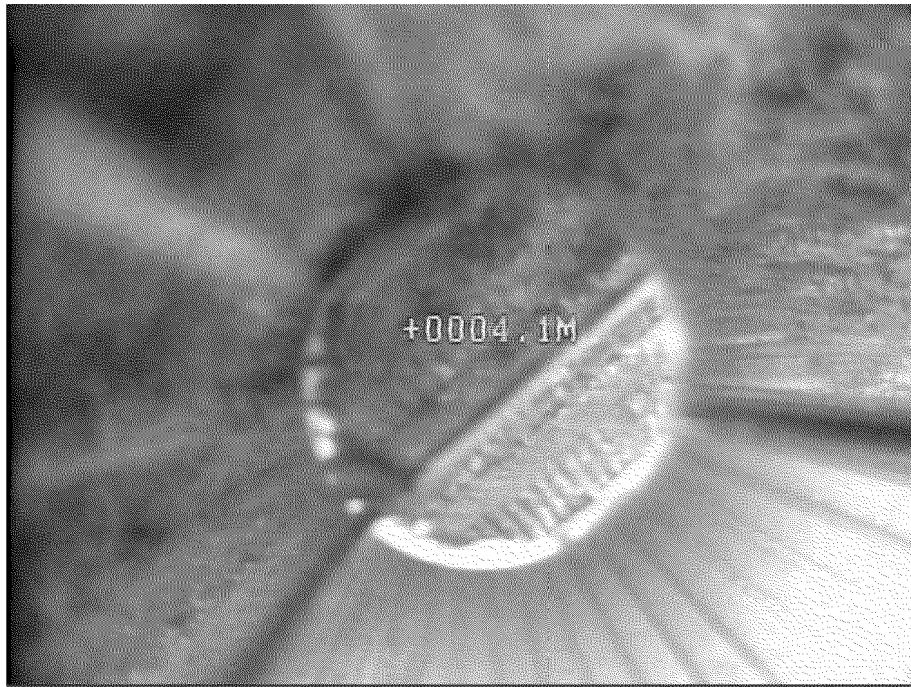
VST_02_4.VOB at 0:10:24

EPA MW02 Well Screen

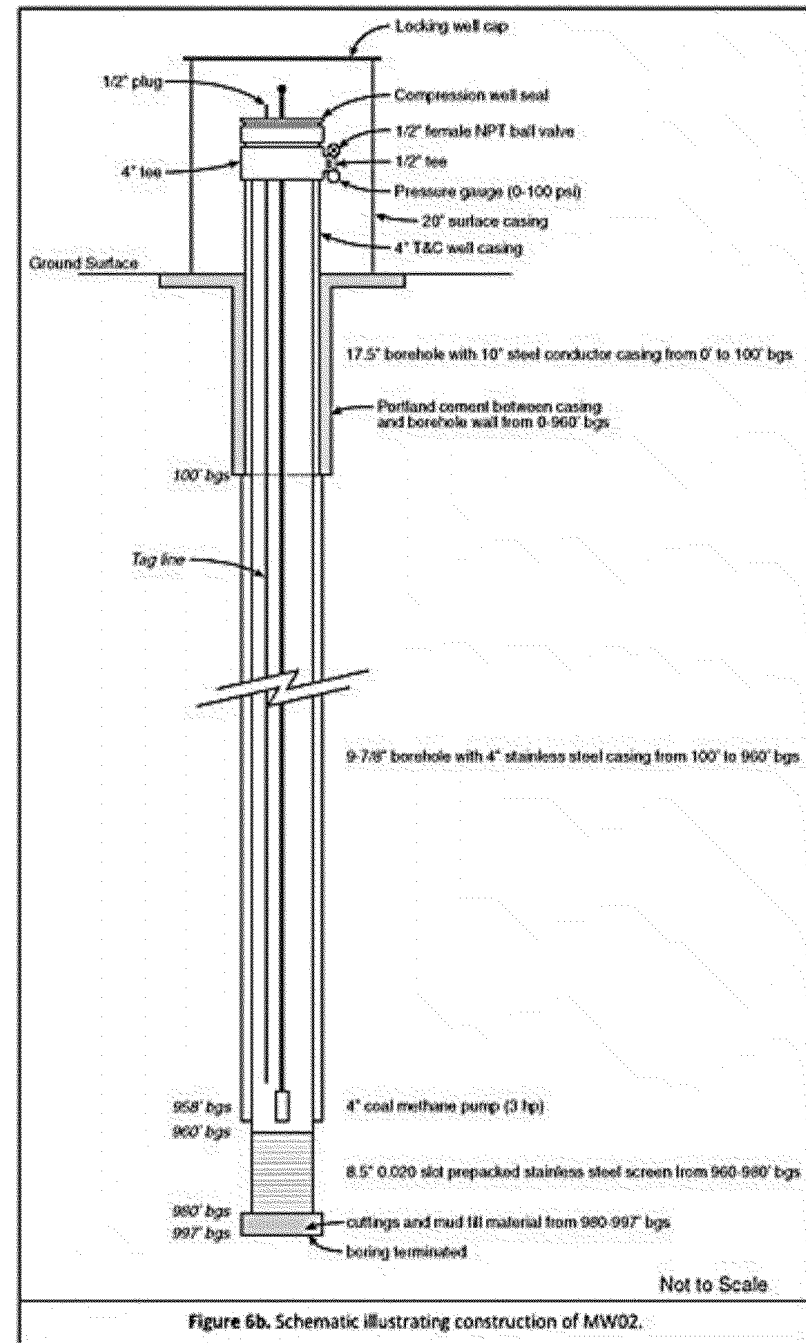
EPA MW02 Well Construction Diagram

EPA well completion log indicates 17-
feet of drill cuttings and mud fill
material in open hole beneath EPA
reported depth of MW02.

Open threads observed in video suggest
well was completed to a depth deeper
than reported by EPA, this was
confirmed by USGS.

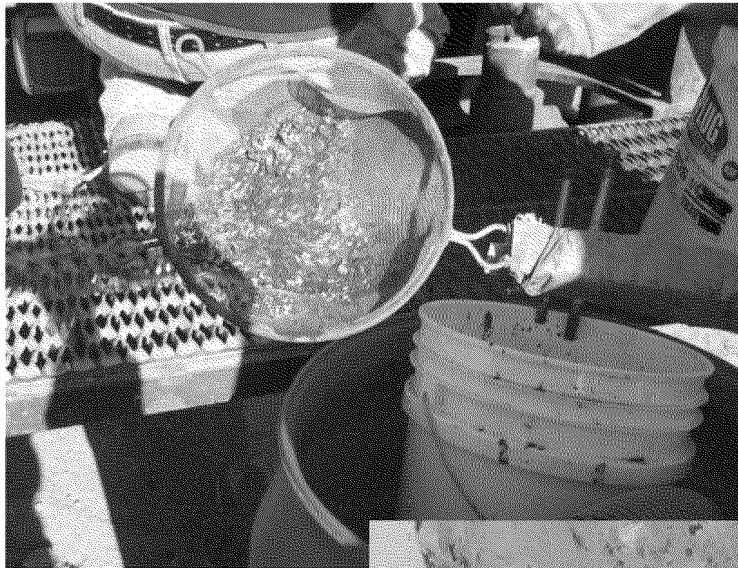
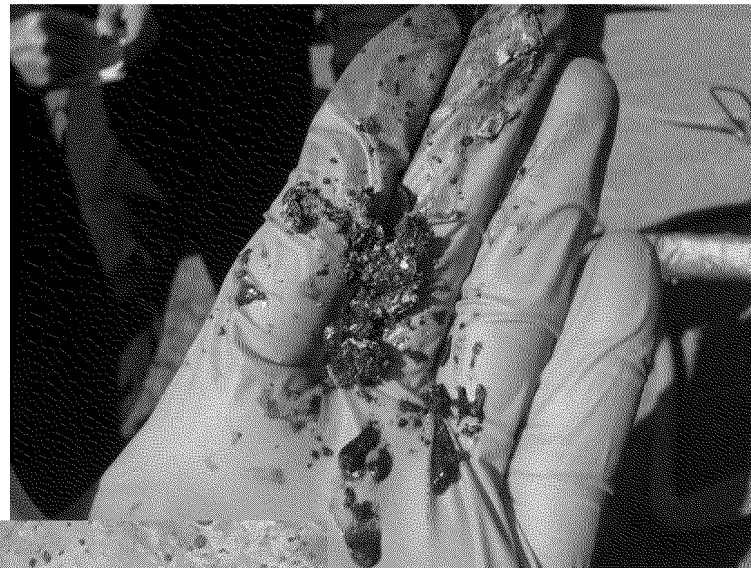
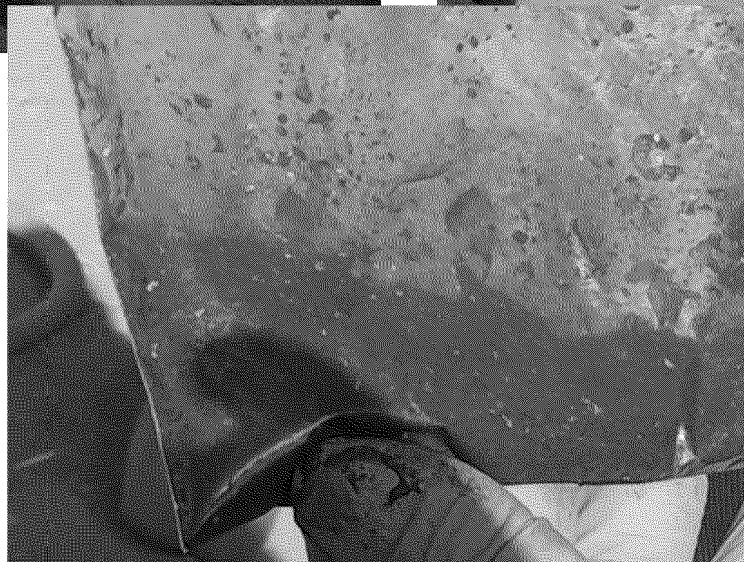
Material removed from MW02 during redevelopment of well by USGS, May 2012
